## Confidential Inspection Report

**Property Address:**  
1234 Sunrise Drive  
Hailey ID 83333

**Sun Valley Home Inspections, LLC**

<b>Date:</b> 6/2/2009	<b>Time:</b> 02:00 PM	<b>Report ID:</b> Doe, John and Jane
<b>Property:</b> 1234 Sunrise Drive Hailey ID 83333	<b>Customer:</b> John and Jane Doe	<b>Real Estate Professional:</b>

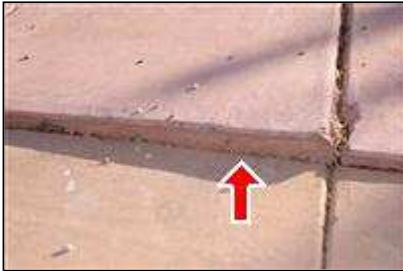
1.1 Picture 1

**1.1** Concrete sections at rear patio are cracked and heaved in some areas causing possible trip hazards.

Concrete sections at rear patio are cracked and heaved in some areas causing possible trip hazards.

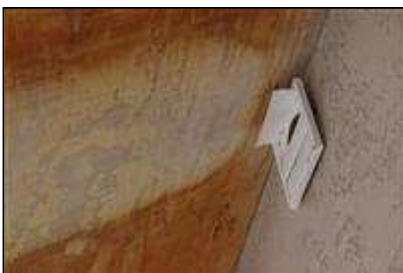
1.3 Picture 1

**1.3 (1)** Soffit finish is bleached from dryer vent exhaust (east wall).

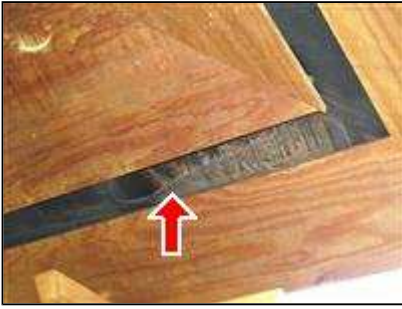
1.3 Picture 2

**1.3 (2)** Soffit screen at NW corner was damaged. Probably due to squirrel intrusion.

(2) Soffit screen at NW corner was damaged. Probably due to squirrel intrusion.

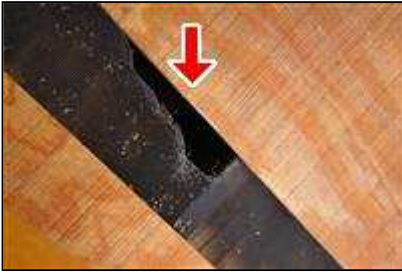
2.4 Picture 1

**2.4** *Soffit screen torn at north end. Appears due to vermin intrusion.*

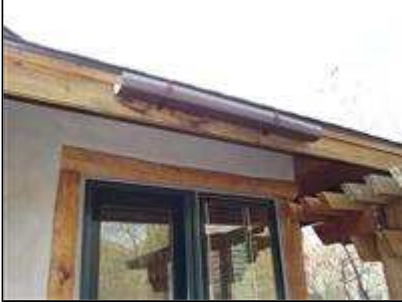
**2.5** *There were two short gutter sections installed over entry doors without downspouts.*

2.5 Picture 1 Gutter without downspout at north entry

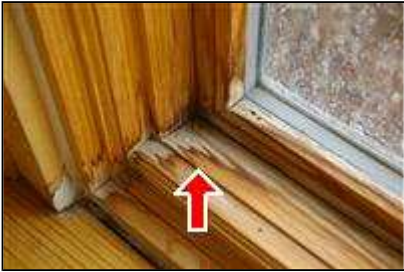
10.6 Picture 1

**10.6** Several window trim is moisture stained. Probably due to condensation in winter. I recommend treatment to enhance appearance and to preserve wood.

Several window trim is moisture stained. Probably due to condensation in winter. I recommend treatment to enhance appearance and to preserve wood.

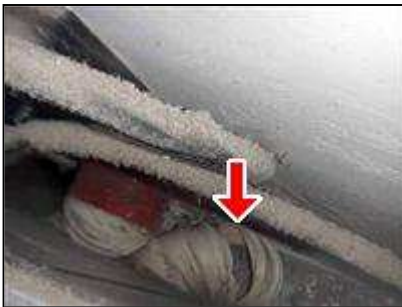
11.15 Picture 1

**11.15 (2)** *Clothes dryer vent pipe at dryer rear was torn and needs replacing.*

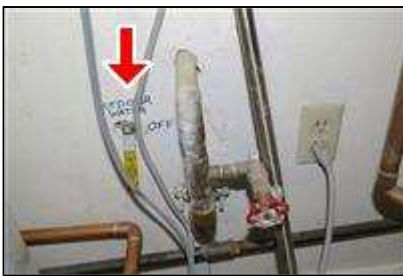
12.4 Picture 1

**12.4** *Activating the main water shut-off device is outside the scope of a General Home Inspection. Performed visual inspection only.*

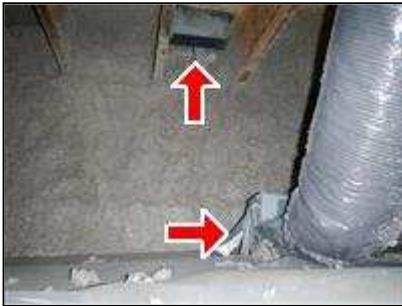
14.9 Picture 1

**14.9** One duct in crawlspace was detached. Minor repair

One duct in crawlspace was detached. Minor repair

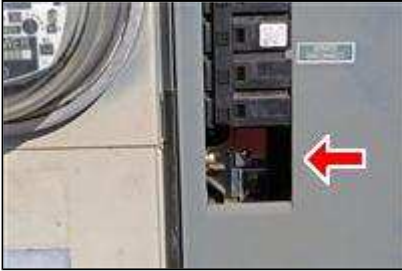
15.2 Picture 1

**15.2** Some knock-outs in the dead front (cover of the main panel) were missing. This is not a proper repair and is considered a safety hazard as live components of the electrical system are potentially exposed. *While this is not a difficult repair, I recommend that the work be done by a qualified electrician to prevent injury/electrical shock.*

Some knock-outs in the dead front (cover of the main panel) were missing. This is not a proper repair and is considered a safety hazard as live components of the electrical system are potentially exposed. *While this is not a difficult repair, I recommend that the work be done by a qualified electrician to prevent injury/electrical shock.*

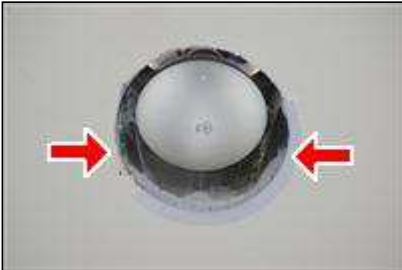
15.4 Picture 1

**15.4** One recessed light fixture at living room ceiling.

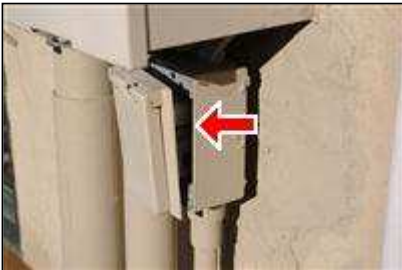
15.6 Picture 1

**15.6** GFCI outlet at main electrical panel had a detached cover. Minor repair

GFCI outlet at main electrical panel had a detached cover. Minor repair
